# "I Am Only Verifying Voltage Is Off"

by Tony Demaria Tony Demaria Electric, Inc.

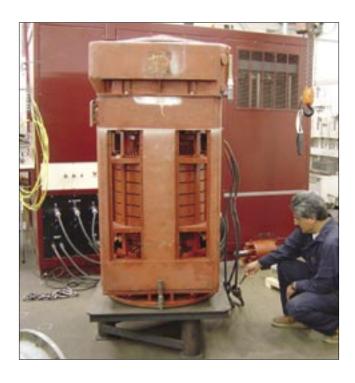
A technician has opened the breaker on the test panel feeding a 2300 V 3600 HP vertical motor being run for test purposes.

The technician is using a voltage detector to test for absence of voltage. What is wrong with this picture?
